Preseismic Assessment of the Traditional Dwellings and Vulnerability Assessment of the Old town of Rhodes

FIRST DEGREE PRE-EARTHQUAKE ASSESSMENT

OF THE BUILDINGS CONSTRUCTED DURING THE OTTOMAN PERIOD IN THE

OLD TOWN OF RHODES

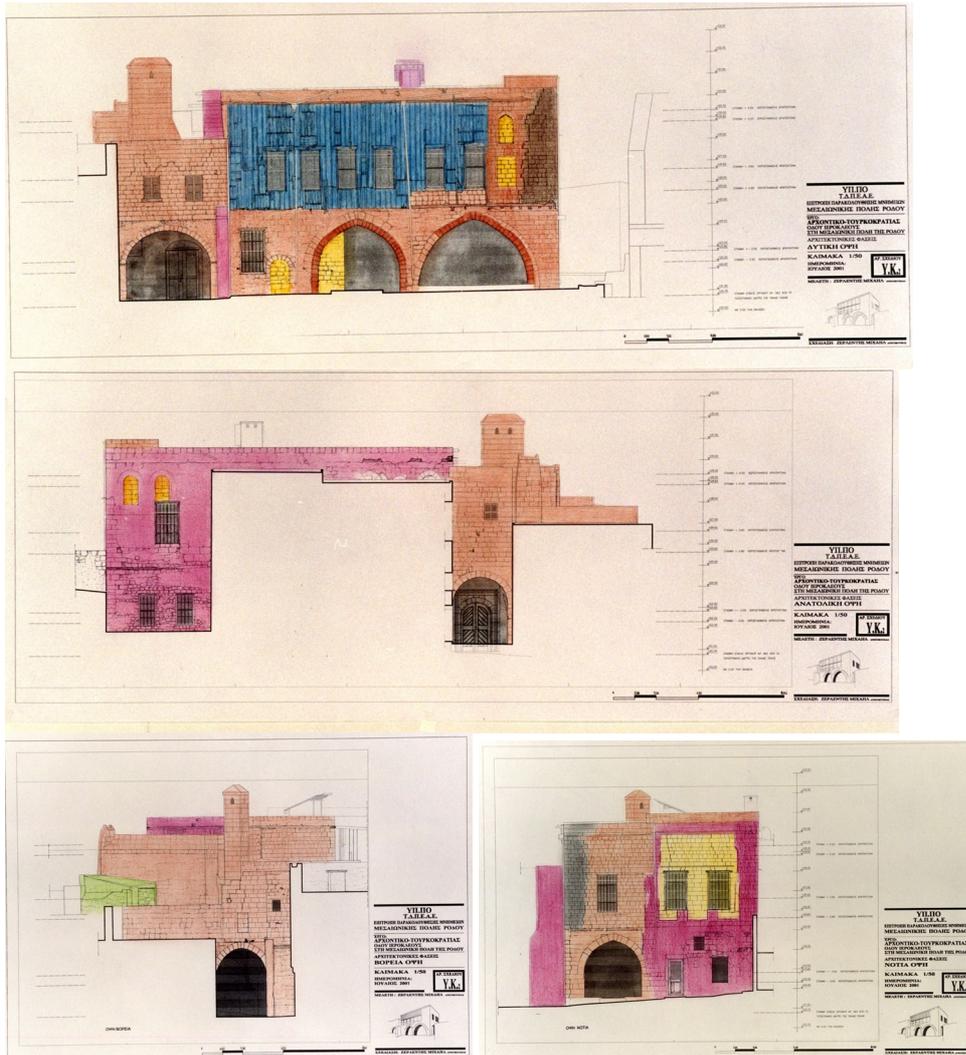
Figure I.2. Views of the structure!

The structural cross-walls of the upper floor suffered from cracks with significant width and almost all the pillars as well as on the rest of the areas between the openings were heavily cracked. In addition, the east wall was almost detached. The wooden support beams and the secondary features were in bad condition due to humidity and dereliction.

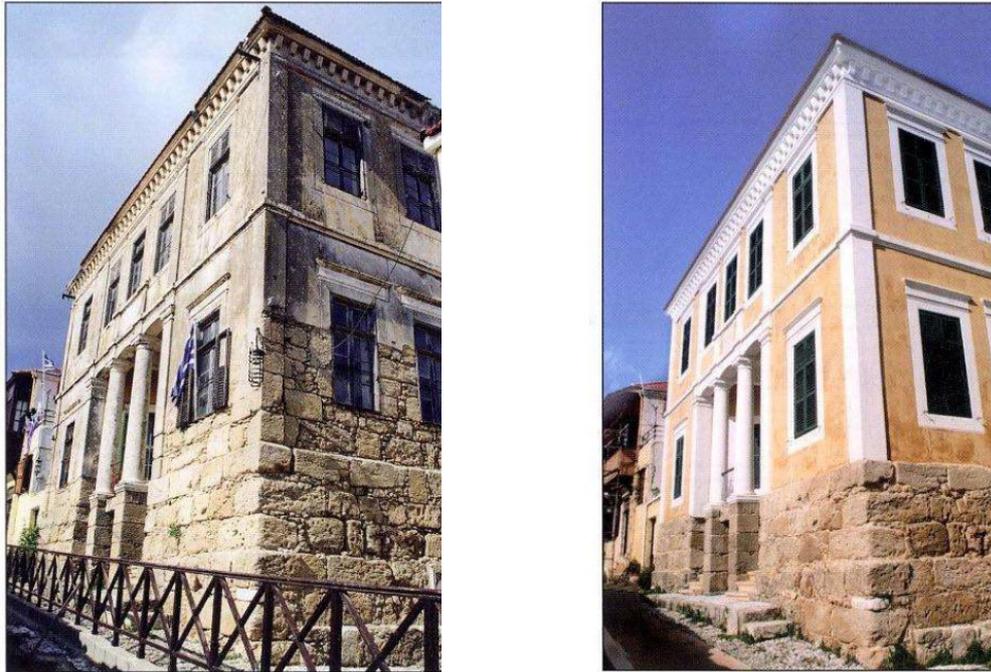
Figure I.5. View from the street before and after the restoration works

Before the restoration works at the fourth Byzantine tower with the old Ottoman court, numerous cracks appeared in masonry. After removing the loose coatings, the initial condition of the walls was restored by blocking and stapling the cracks. In addition, it was deemed necessary to strengthen the four-pitched wooden roof. The frames also showed structural problems as well as the the first floor and the rooms on the ground floor. Small cracks were also observed in the stone structures of the surviving part of the second from the west Byzantine tower.

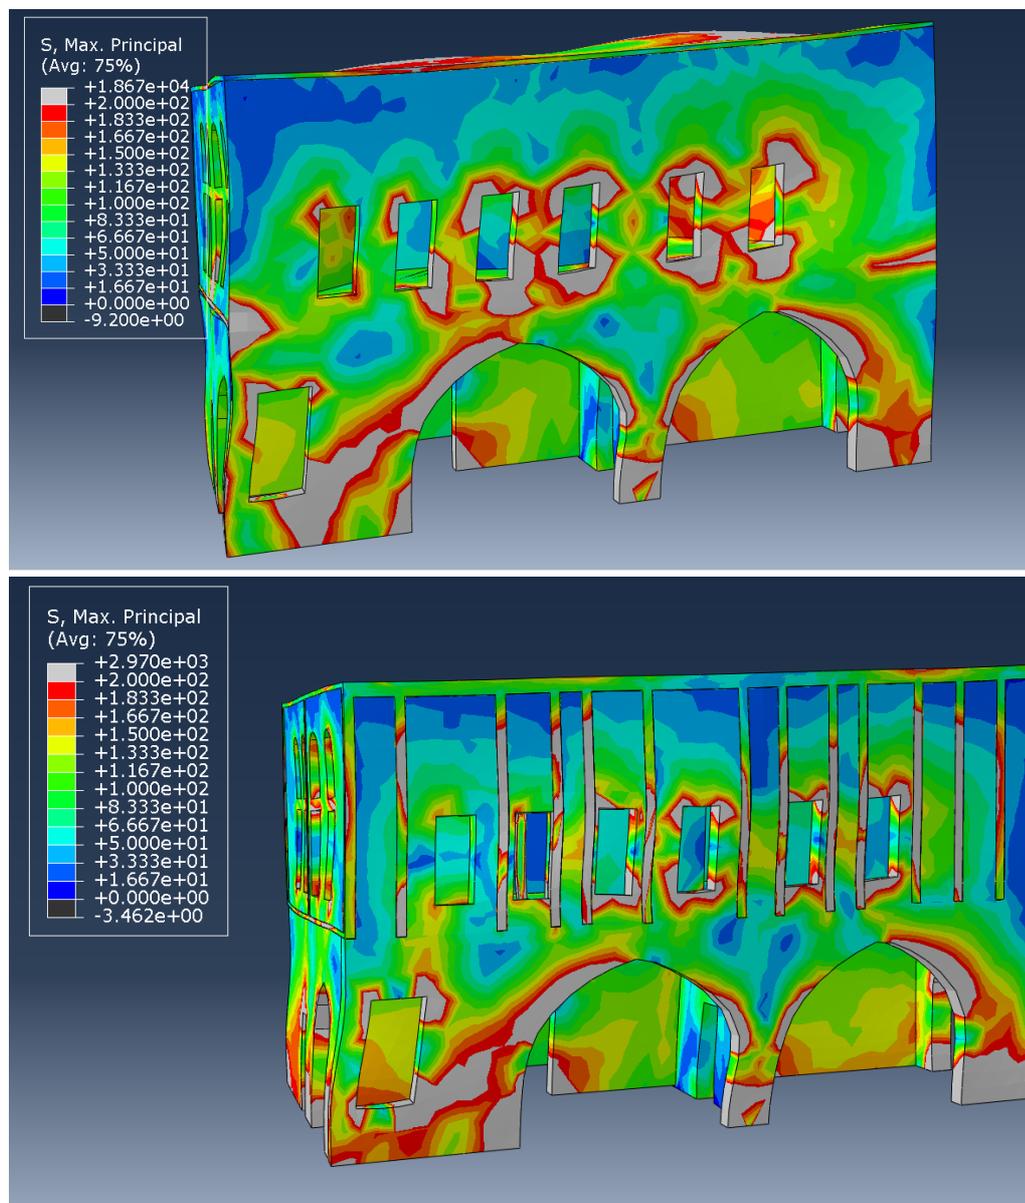
Figure II.2. Principal tensile stresses without and with timber framed masonry wall in upper floor.

From Figure II.2. it is easily concluded that the total area of the upper walls, where the tensile strength is exceeded, is smaller in the case of timber framed masonry walls. Therefore, it can be concluded that both the stresses and the displacements of the masonry of the upper floor are reduced due to the addition of wooden elements, a fact that enhances the seismic response of the construction.

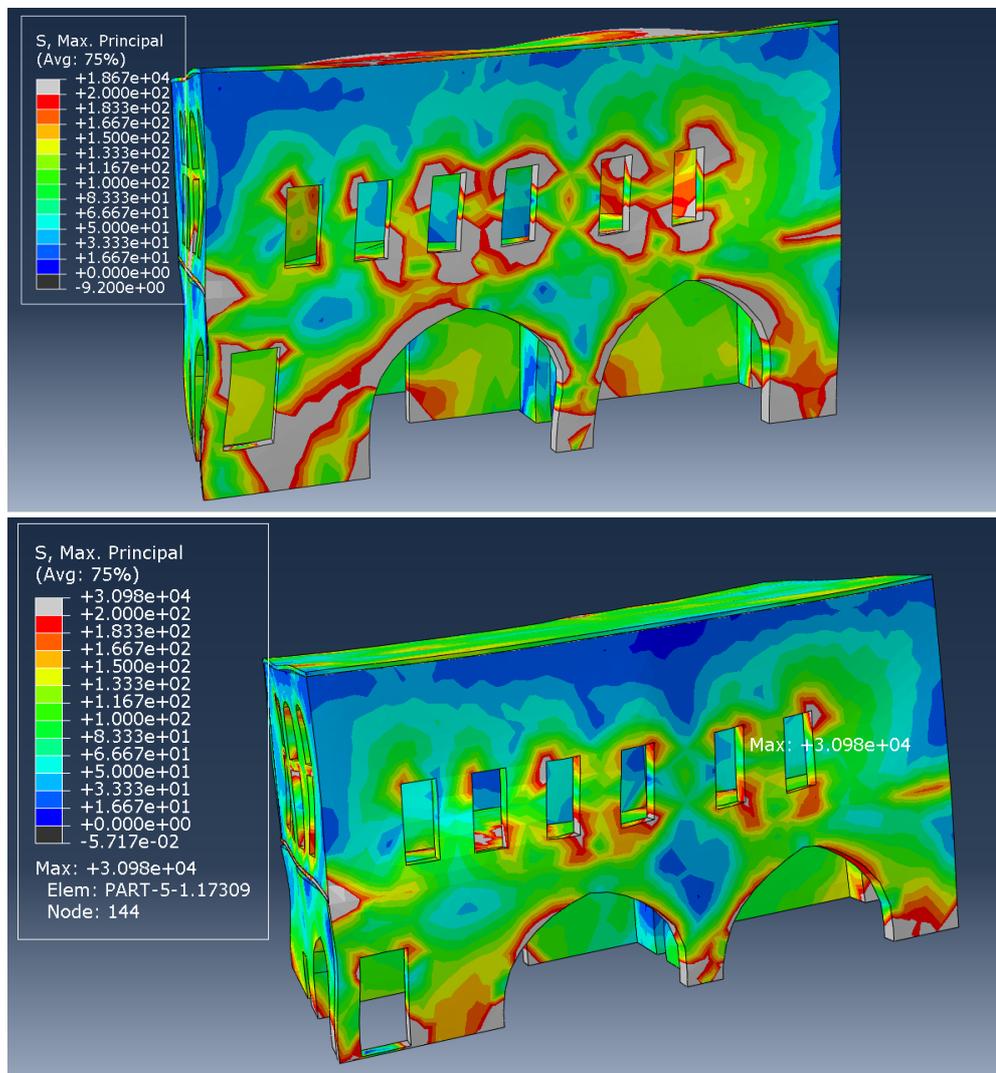
Figure II.4. Principal tensile stresses for the cases of 4.5m (a) and 3.5m (b) height of ground floor.

The comparison of the pictures leads to the conclusion that the tensile stresses as well as the displacements are obviously reduced, a fact that justifies the differentiation in the categories of parameter 48 in the pre-earthquake assessment data sheet.

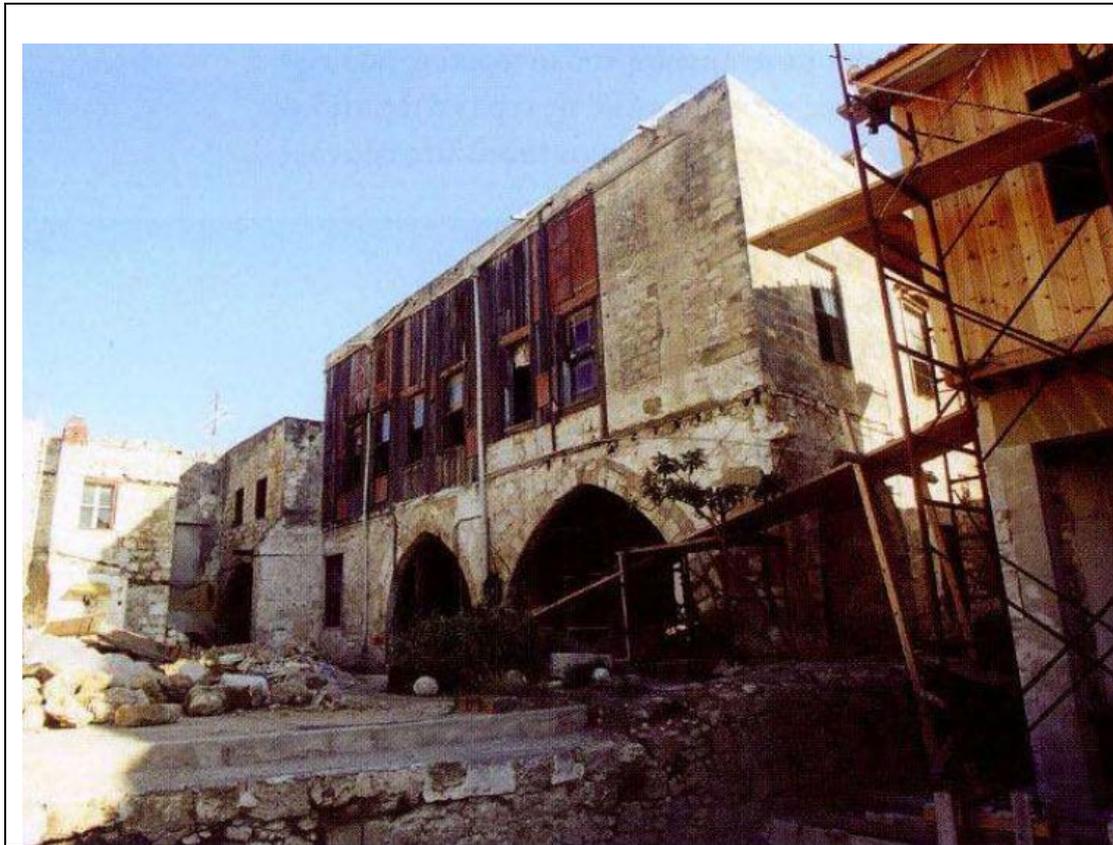
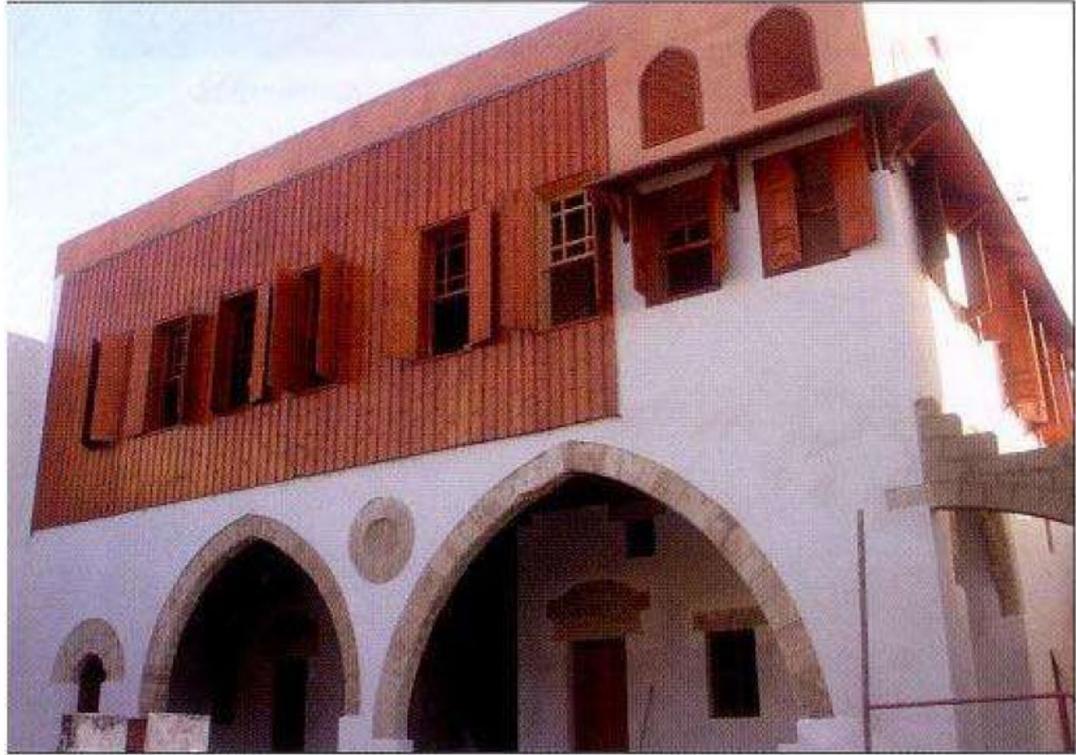
Figure shows the conditions of the building before and after the restoration works applied after 2001.

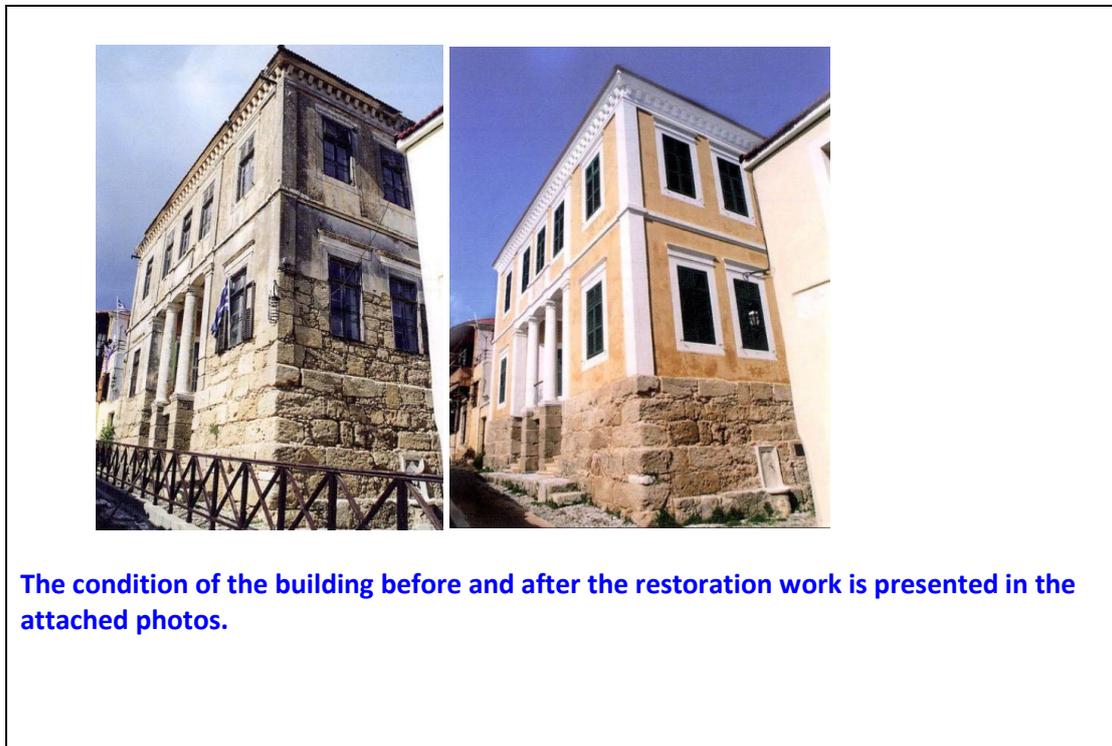
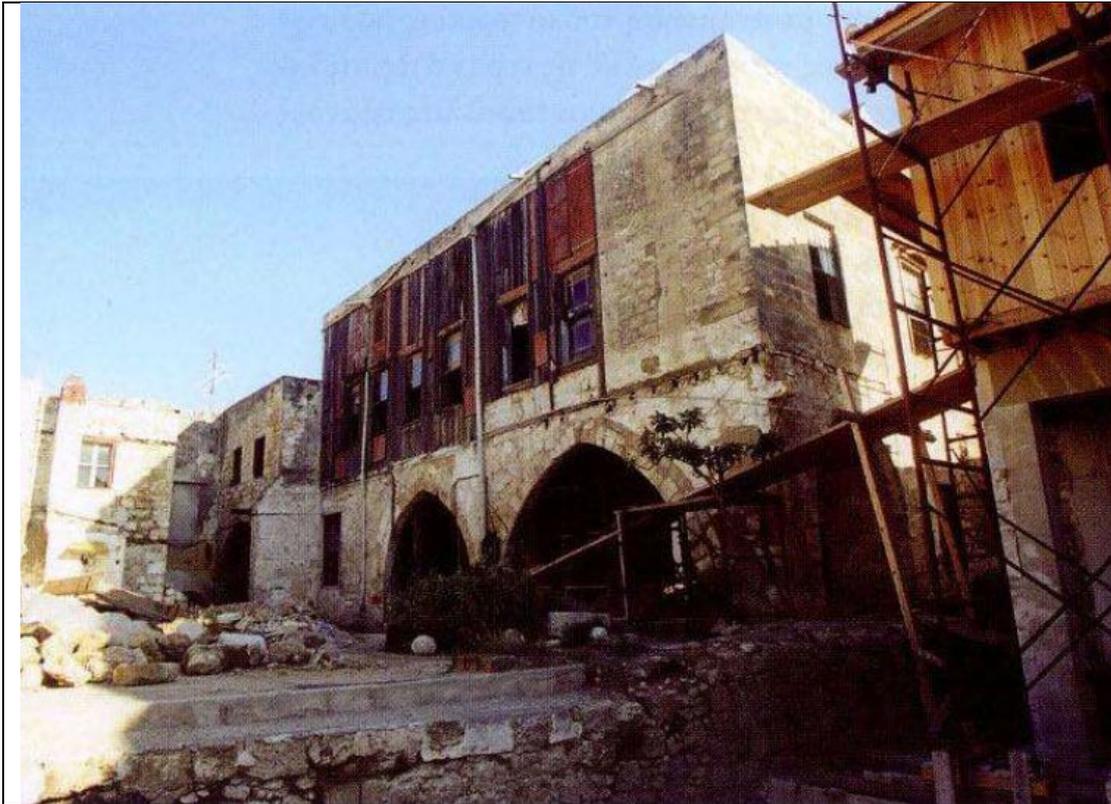
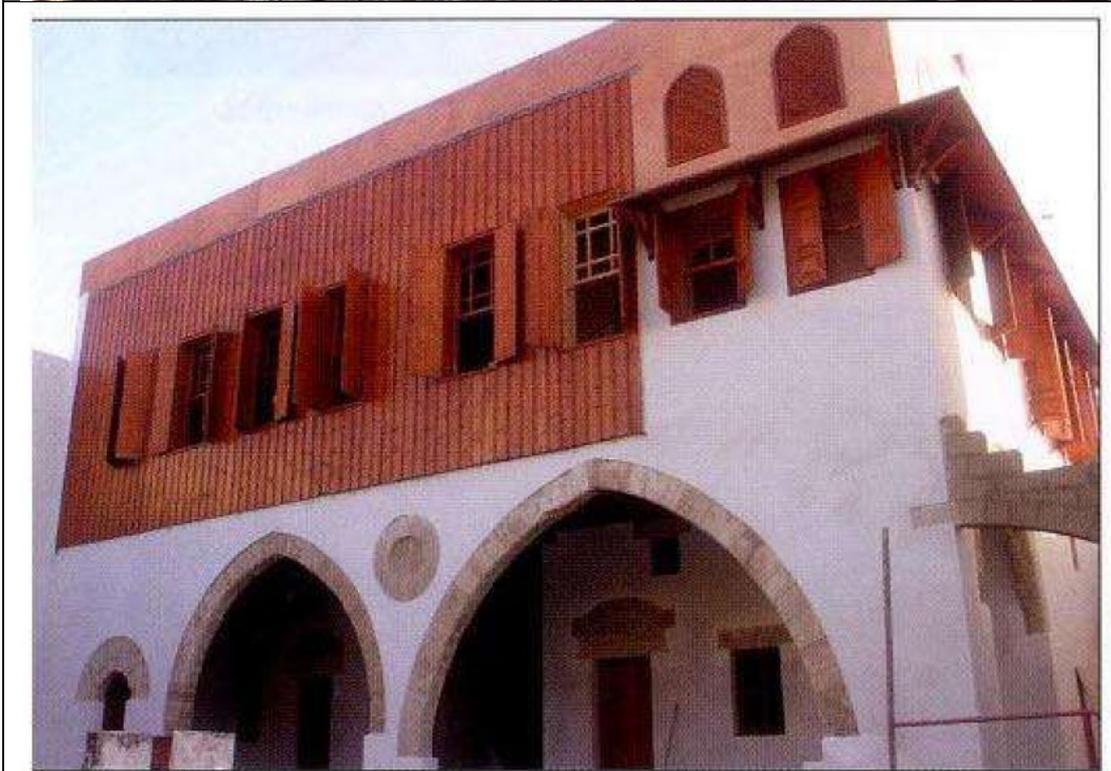
Figure shows the conditions of the building before and after the restoration works applied after 2001.
