«Atlas of the Monuments of Greece classified according to their seismic behavior»

1st action of EPPO

December 2022

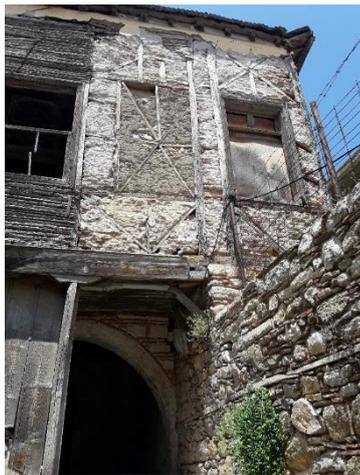
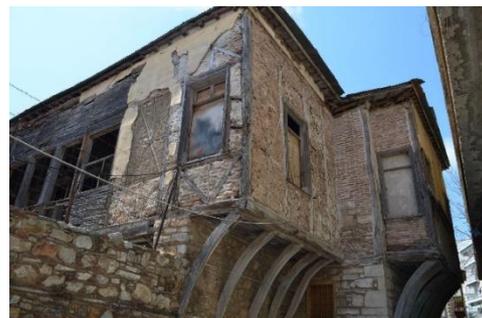
Timber framed external walls
